**BUILDING DEMOLITION & SITE GRADING
2202 Soquel Avenue, Santa Cruz, CA**

PROJECT #23TI-064

GEOTECHNICAL INVESTIGATION FEASIBILITY PHASE

FOR
2202 SOQUEL AVENUE
SANTA CRUZ, SANTA CRUZ COUNTY, CALIFORNIA

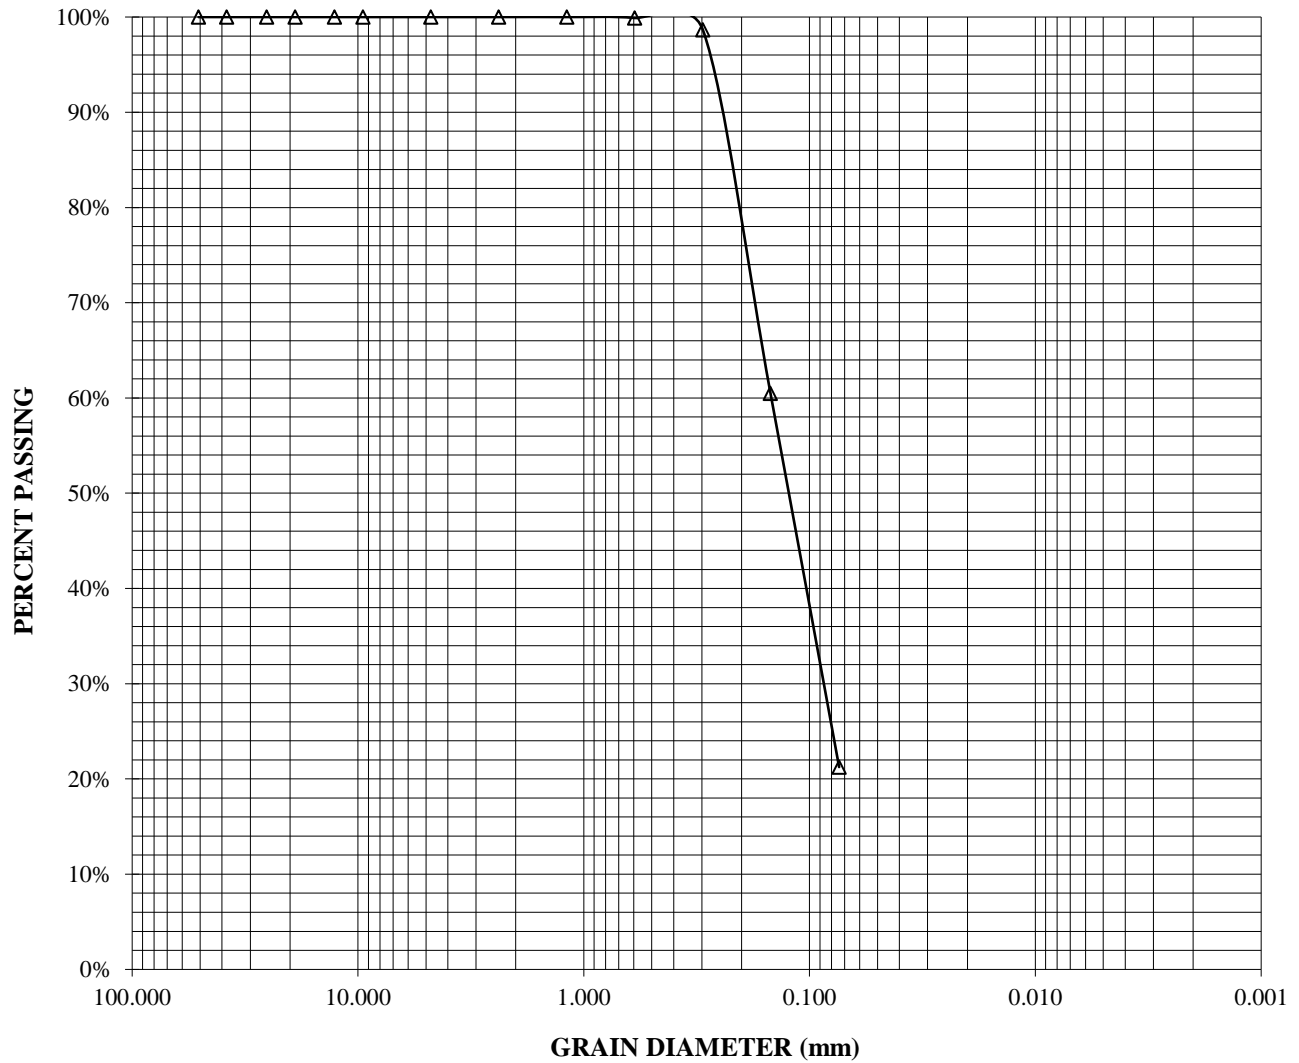
FIGURE
 C-2

BORING:	B4-4	PERCENT	PERCENT
DEPTH (ft):	25.0	PASSING No. 4	PASSING No. 200
SOIL TYPE (USCS):	SM	100.0%	21.3%

GRAIN SIZE DISTRIBUTION
 2202 Soquel Ave

Four sieves were performed on representative sample in accordance with ASTM C 117 and C 136. The grain size distributions from the results of the particle size analyses are shown on Figures C-1 through C-4.

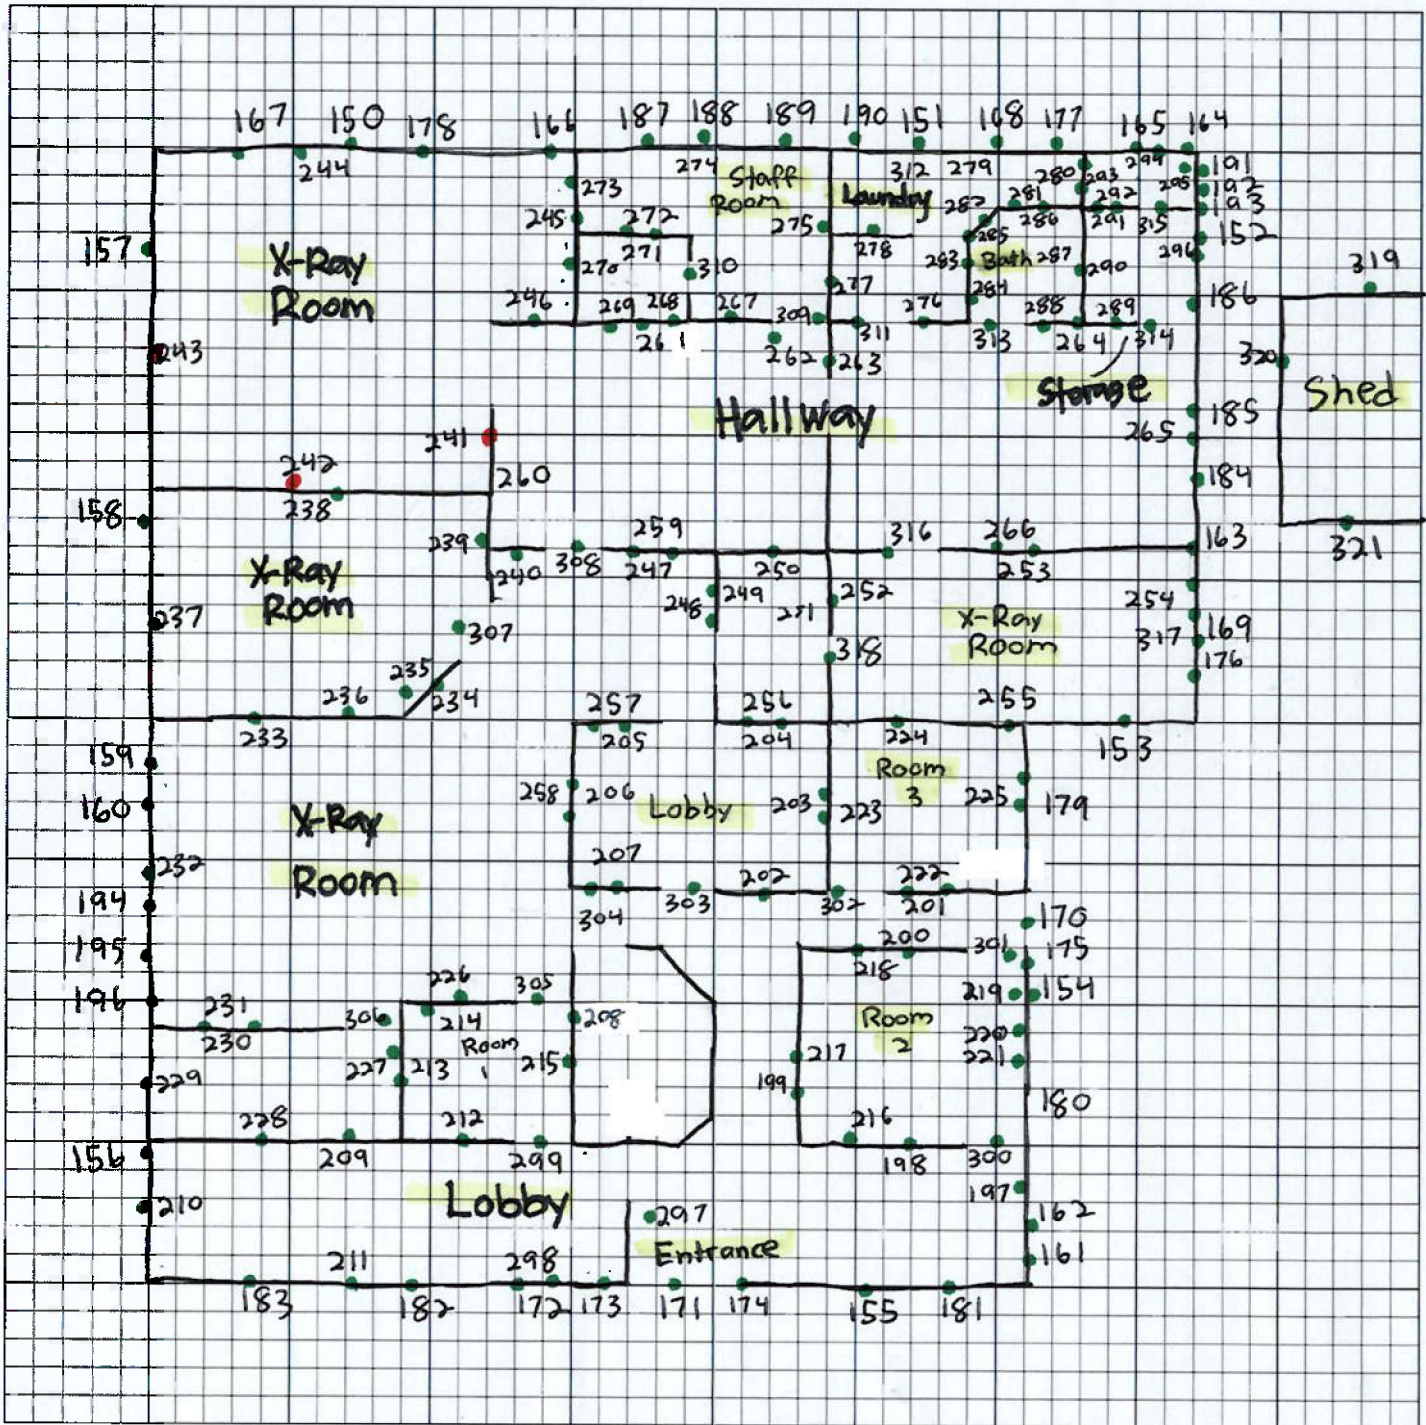
Site Map: Lead Survey

Project #:	2309-67L-CSC
Address:	2202 Soquel Ave., Santa Cruz, CA 95062
Date:	September 21, 2023
Project Manager:	Frank V.

- B - Bulk Sample
- Lead Based Paint Detected
- No Lead Based Paint Detected
